SAFETY ALERT Contractor

DIVISION: Outside Contractor (not involved in RFP operations)
DEPARTMENT: Maintenance
DATE: December 2015 (*CNESST* report issued in September 2016)
TIME: N/A
TYPE OF INCIDENT: **Fatality** (outside Contractor, not involved in RFP operations)

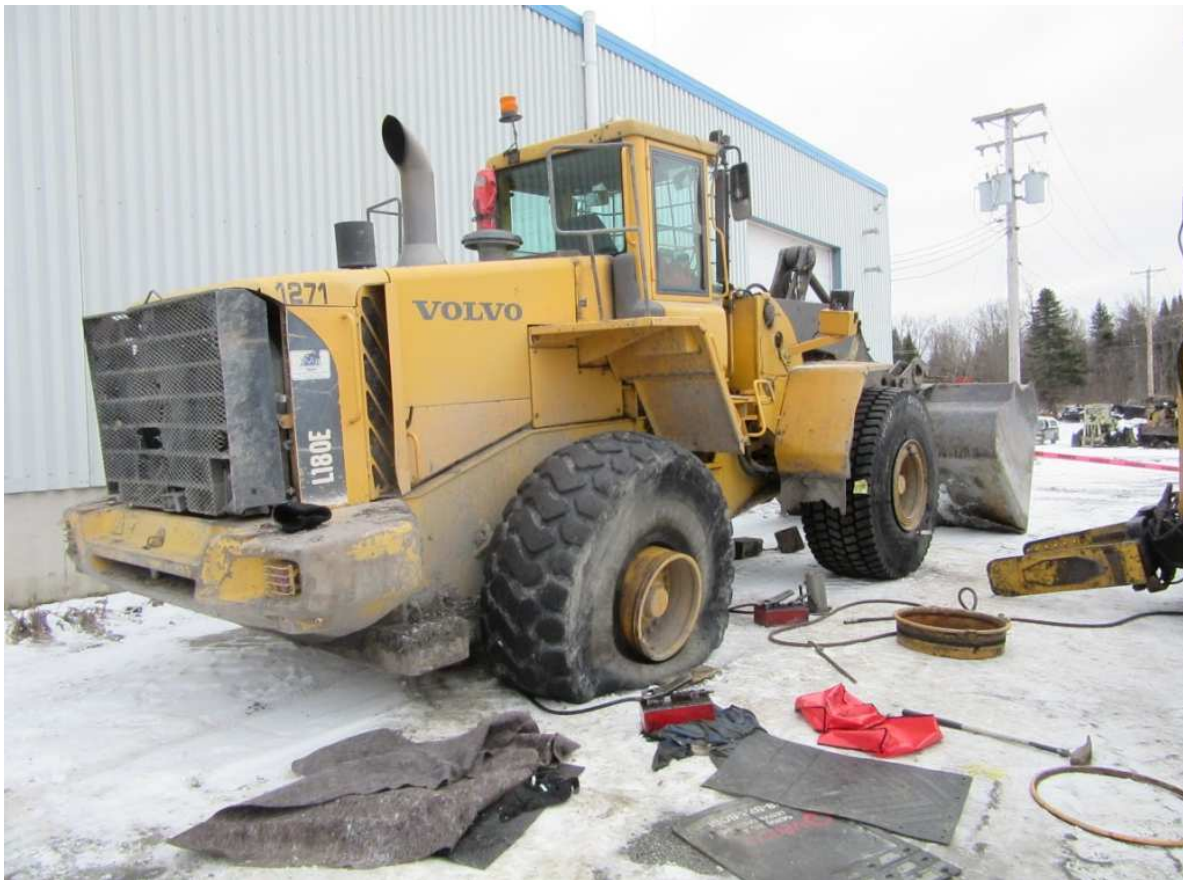
Accident site

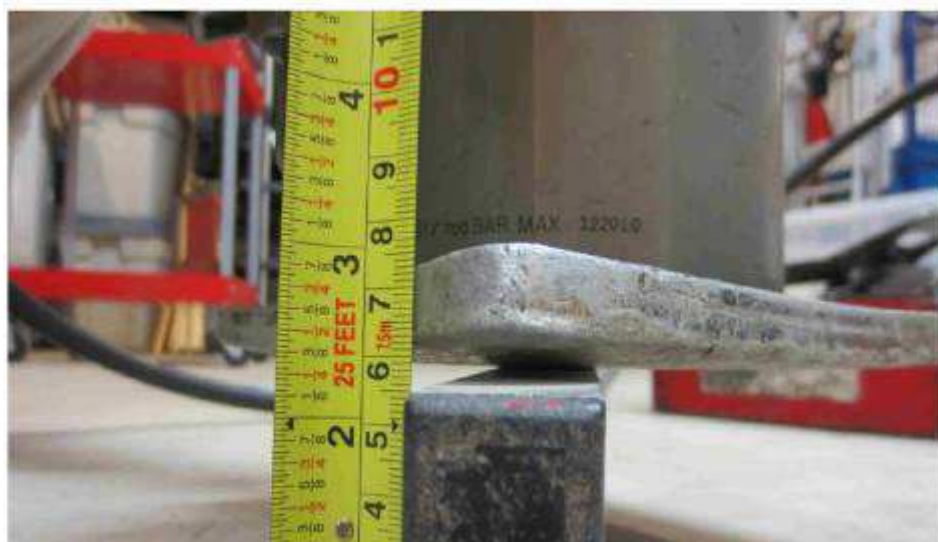
Jack base (curved)

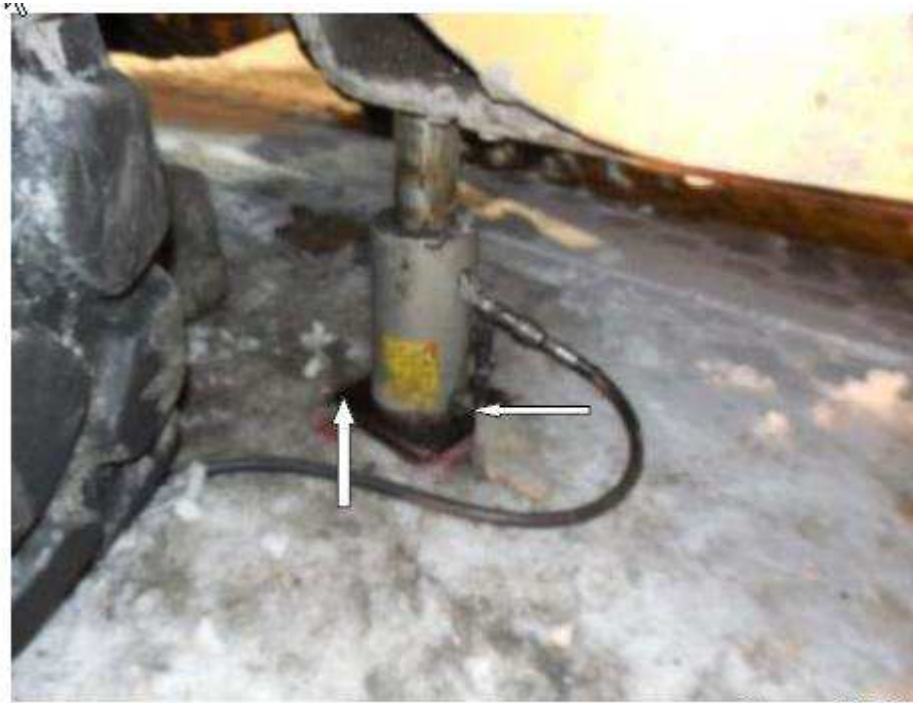
Hydraulic oil leaks visible in the snow

Leaking hydraulic jack

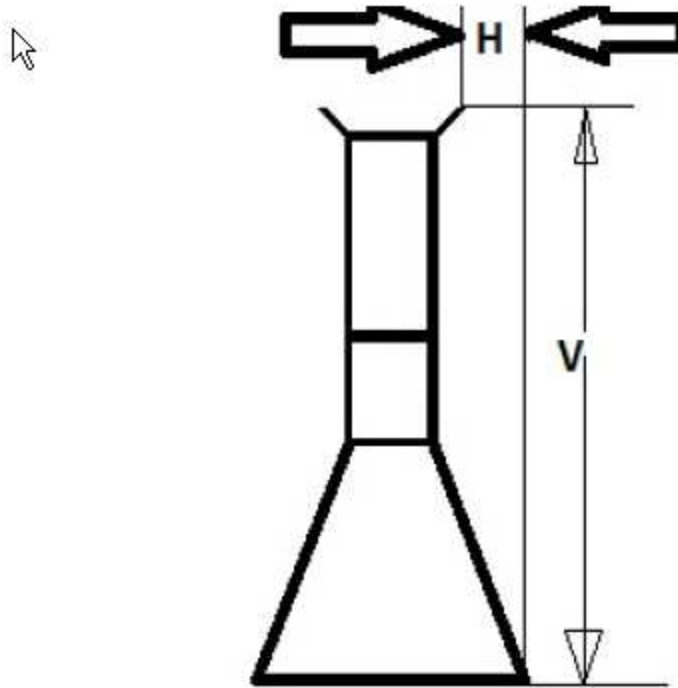
Ratio between H and V must be at least 8%

Standard ASME B30.1-2009, “Jacks, Industrial Rollers, Air Casters, and Hydraulic Gantries” deals with hydraulic jack quality and establishes rules for their safe use.

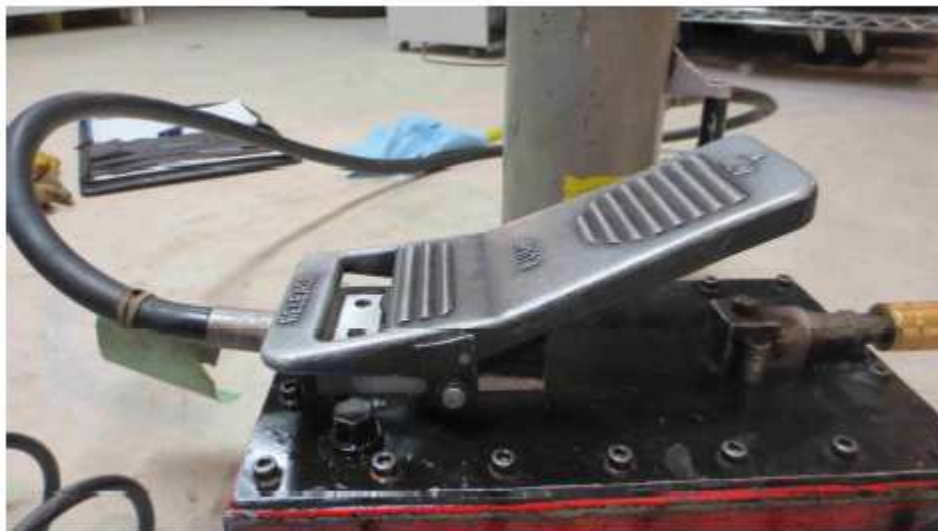
Picture #8 - Pump pedal stuck in the “Return” position
