OCCUPATIONAL SAFETY & HEALTH
REPORTING EVENTS AND INCIDENTS
APPENDIX 3

SAFETY ALERT
Contractor

DIVISION: St-Félicien Kraft
 DEPARTMENT: Maintenance
 DATE: November 18, 2018
 TIME: Undetermined
 TYPE OF INCIDENT: **Gas Explosion - Property Damage- High Severity Potential**

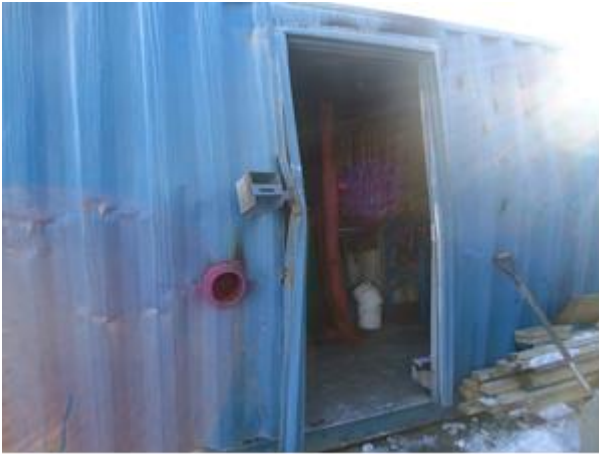
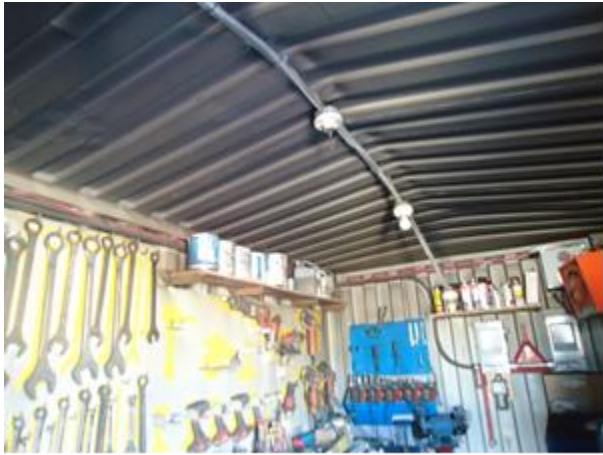
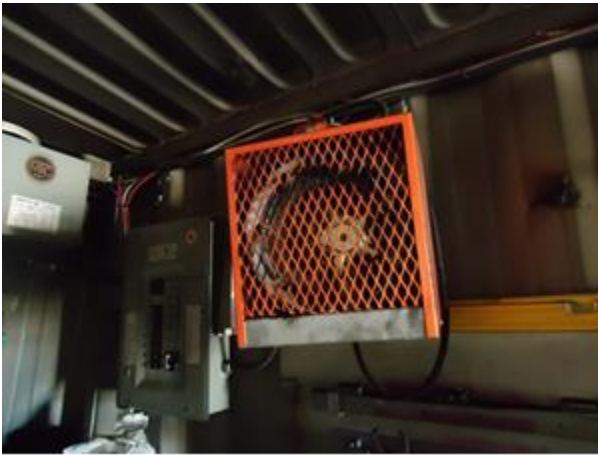
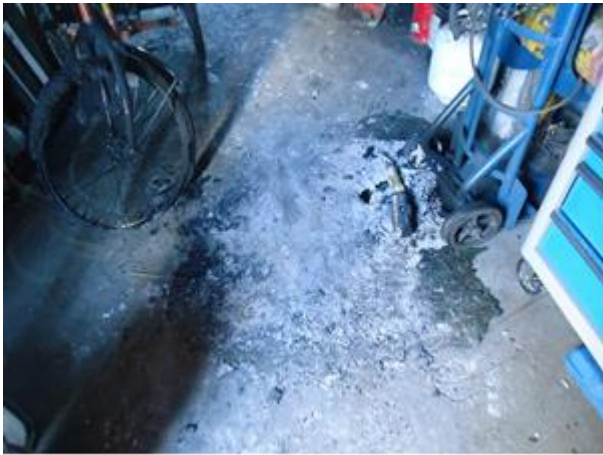
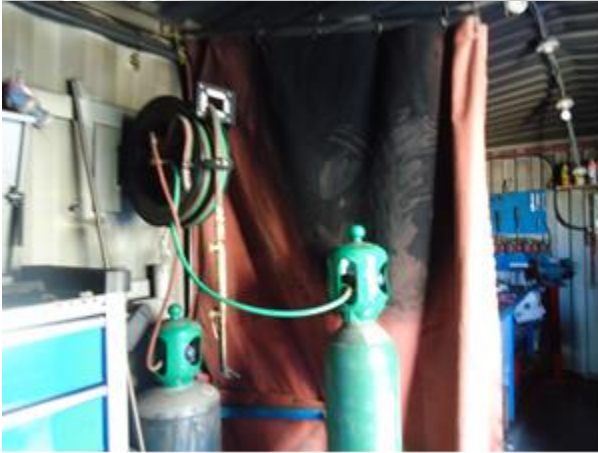
PICTURES

During the night of November 17 to 18, an explosion occurred in Contractor Desco container. Contractor employees discovered the damages when they reported to work on Sunday morning, November 18.

So, at the end of Saturday work shift, Desco employees left the premises leaving an acetylene cylinder improperly closed stored inside *the container Contractor uses as a workshop*. Acetylene cylinder was connected to a cutting nozzle and gas coming out of the nozzle mixed with ambient air inside the container until it reached a concentration > 2.5%. At some time, the container electrical heating system automatically came on, creating the ignition source required for the explosion. (Leak was also confirmed by equipment tests.)

The blast caused the container walls and ceiling to bulge, tearing off the side door and the locking system on the large *access door* at the end.

Flame from the explosion then lit up the cutting nozzle, which explains the presence of acetylene soot *on the fireproof curtain*. A plastic pail located in the center of the container, which contained a plastic tarp and a sledgehammer for sure and possibly some waste, caught fire. Combustion was complete, even burning the tires of a bicycle and a hand truck nearby. Examination of soot deposits confirms that the pail fire occurred after the explosion. This fire went out after some time. When workers arrived on location, fire at the nozzle was also out, either due to the wind, or the decrease in oxygen during the pail fire, or the lower acetylene pressure as the temperature decreased.

- A. Acetylene explosion within an enclosed space.
- B. Acetylene cylinder valve left open *in an inside non-ventilated space.*

Move flammable compressed gas cylinders outside.

1. Ensure a documented directive is issued and understood by all our employees and contract workers on your sites regarding the ban on the storage of flammable compressed gas inside **containers or restricted NON-VENTILATED enclosed spaces.**
2. *Ensure an inspection is conducted on compliance with flammable gas cylinder storage in all site operational areas and contractor mobile workshops to measure compliance with Measure #1.*
3. If equipment with flammable gas needs to be stored in *an air-tight storage unit*, **ensure all electrical components within the storage area are classified as explosion-proof.**
